City of Auburn | Water Resource Management

OUR LOCAL WATER RESOURCES

A Workshop Presented by
The Watershed Division or the City of Auburn Water Resource Management Department

Protecting, Preserving, and Restoring Our Local Water Resources

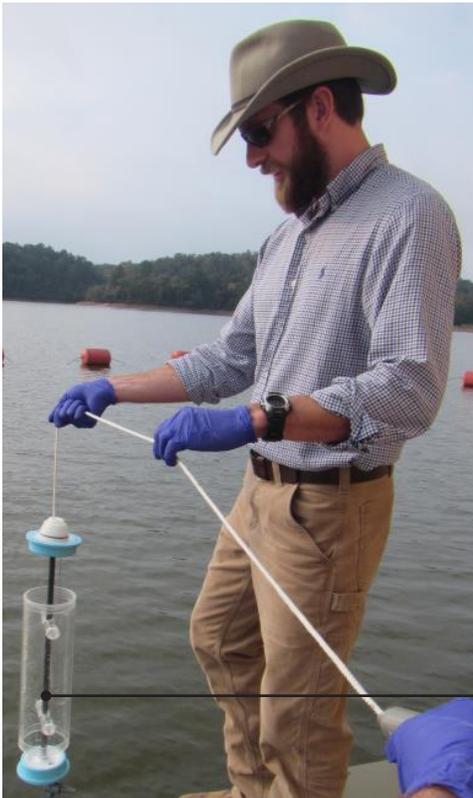
Kemmerer Sampler Used for Obtaining Samples at Specified Depths in Lake Ogletree

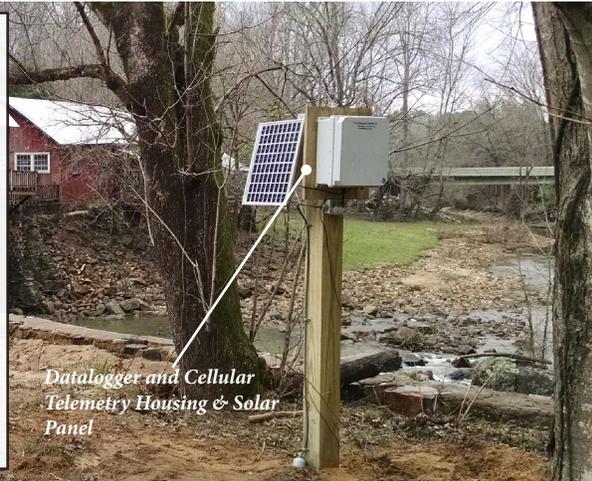
Datalogger and Cellular Telemetry Housing & Solar Panel

3 Gages Owned & Operated by WRM

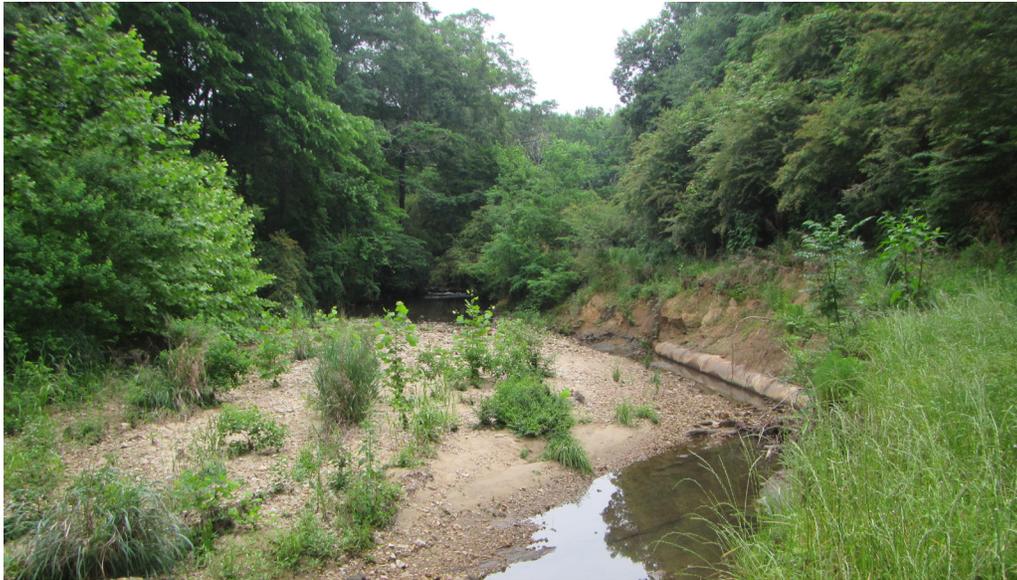
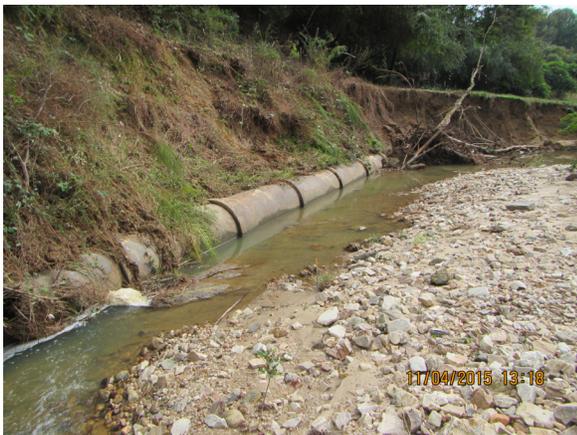
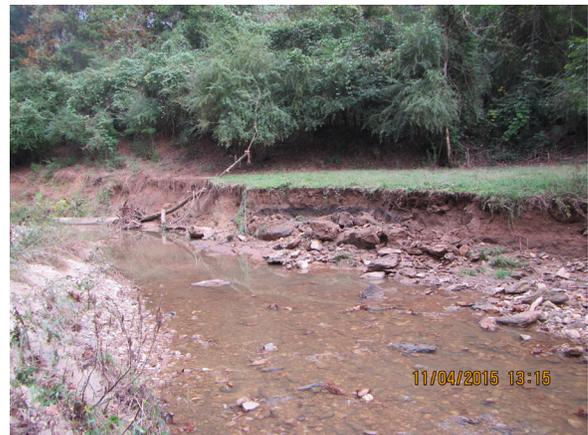
80+ Linear Feet of Exposed Sanitary Sewer Main

Active and Accelerated Lateral Migration of the Stream Channel

Increased Susceptibility to Leaks, Inflow, and Rupture

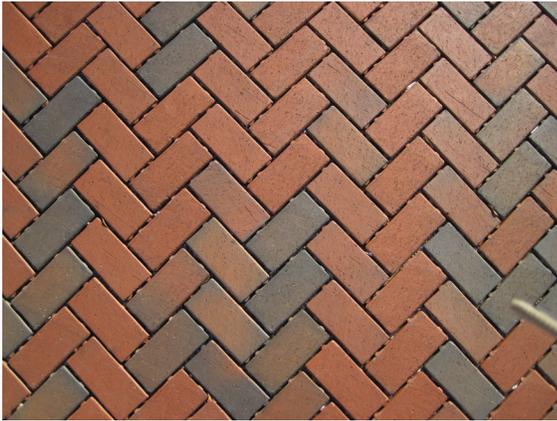
Permeable Interlocking Concrete Pavers

Significantly Improved Infiltration and
Filtration of Urban Stormwater Runoff

Runoff Volume Reduction and Improved
Water Quality

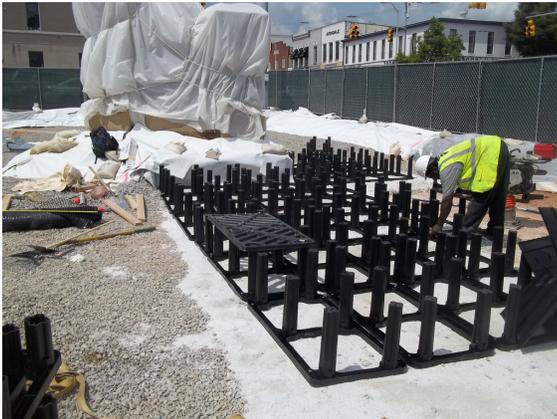
Silva Cell Suspended Pavement

Improved Infiltration and Improved Root
Growth for Street Trees

Runoff Volume Reduction and Improved
Water Quality
